Manhole Inspection Summary

Manhole # S15II1005MH

Insp Date: **12/13/06 2:20 PM**

Location Address: **2407 LOYOLA NORTHWAY**

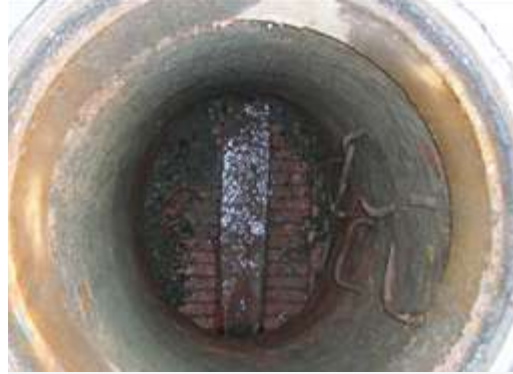
Top View

Corroded and missing steps. Bench debris.

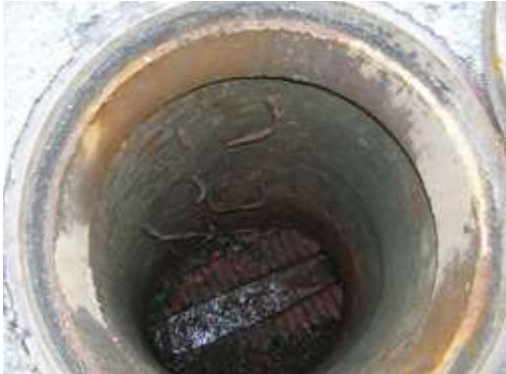
Defect

Frame leaks. Adjustment deterioration and infiltration. Corbel and Barrel infiltration - other side.

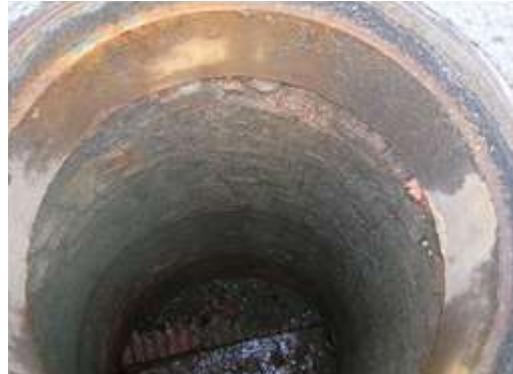
Defect

Frame leaks. Adjustment deterioration and infiltration. Corbel and Barrel infiltration.

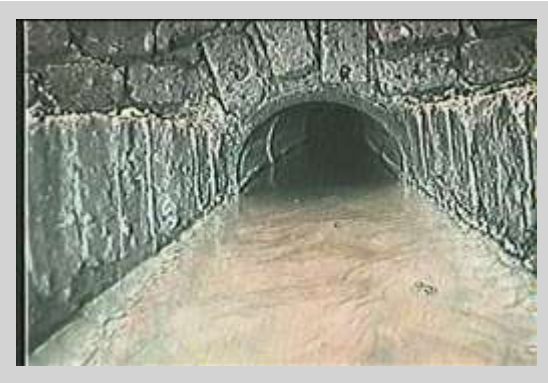
Pipe Out @ 12 O'Clock

Barrel deterioration and infiltration. Channel deterioration.

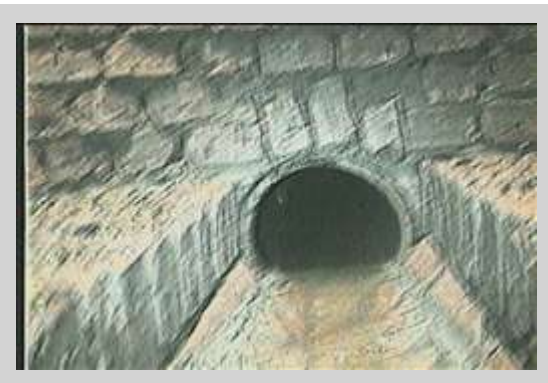
Pipe In @ 6 O'Clock

Barrel deterioration and infiltration. Channel deterioration.
